# **8x930Hx (8x930HD/HE & 8x930HF/HG) SPECIFICATION UPDATE**

Release Date: February, 1999

Order Number: 272962-013

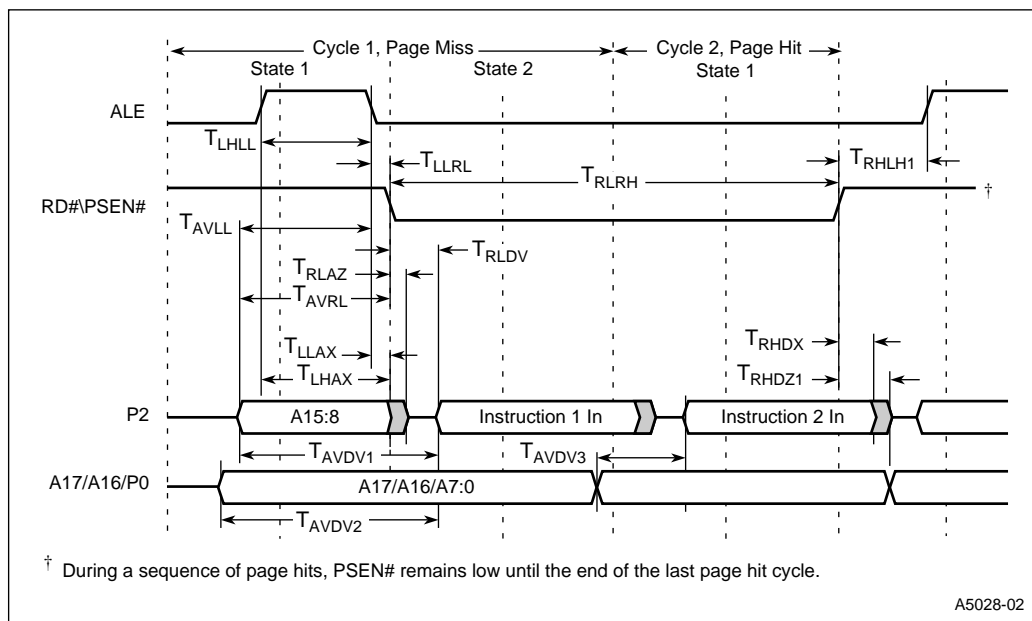
**PROBLEM:** The  $T_{RHDZ1}$  (Instruction Float After RD#/PSEN# High) specification on the 8x930Hx when operating at 12 MHz is 10 ns. However, a slow memory device such as an EPROM typically takes approximately 30 – 90 ns to float its output. (This specification, generically called  $TPHZ$ , may vary depending on the memory type and manufacturer.) Figures 5 and 6 illustrate the  $T_{RHDZ1}$  timing.

The difference between the  $T_{RHDZ1}$  and  $TPHZ$  specifications causes contention on the data bus (P0 in nonpage page, P2 in page mode). The 8X930Hx begins to drive the address for the next bus cycle while the memory device is still driving data from the previous bus cycle.
